# Failure analysis of a heavy gauge fastener of the ITER toroidal field gravity support system

ITER toroidal field  
Gravity support  
Nickel base superalloys  
Delayed failure

## ABSTRACT

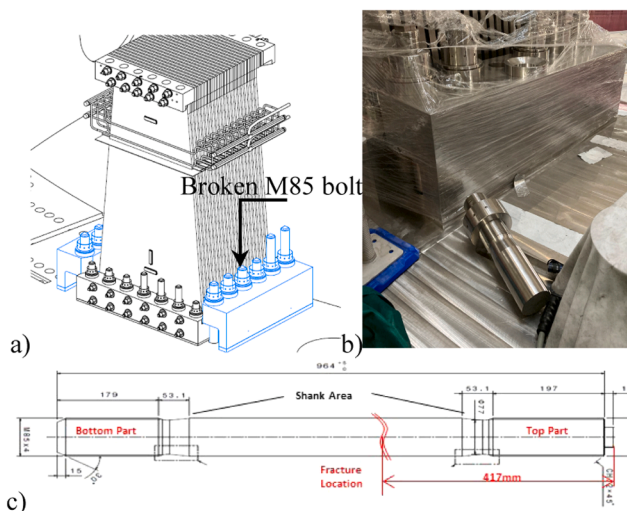
Despite the stringent requirements and the extensive quality controls applied to the forged prematerial and to the bolts, a complete break of one M85 bolt was discovered, that occurred about 40 days after its installation and preloading up to 2.65 MN (45.1% of  $R_{p0.2}$ ), prior to the application of any operating stress. The upper half of the part blew out from the bolthole and was found lying horizontally on the Cryostat Base near the TFGS (Fig. 1) while the lower half part shot downward and lied in the confined space of Cryostat Base. The present paper reports the results of the comprehensive failure analysis carried out following the incident.

**Fig. 1.** a) Complete GS, including M60 and M85 bolts. b) Top part of the broken bolt that blew out from the bolthole. The delayed catastrophic failure occurred near the bottom of an L – shape clamp of the TFGS18, visible on the back. c) Rupture occurred in a full section of the stud, outside the reduced diameter shank areas.

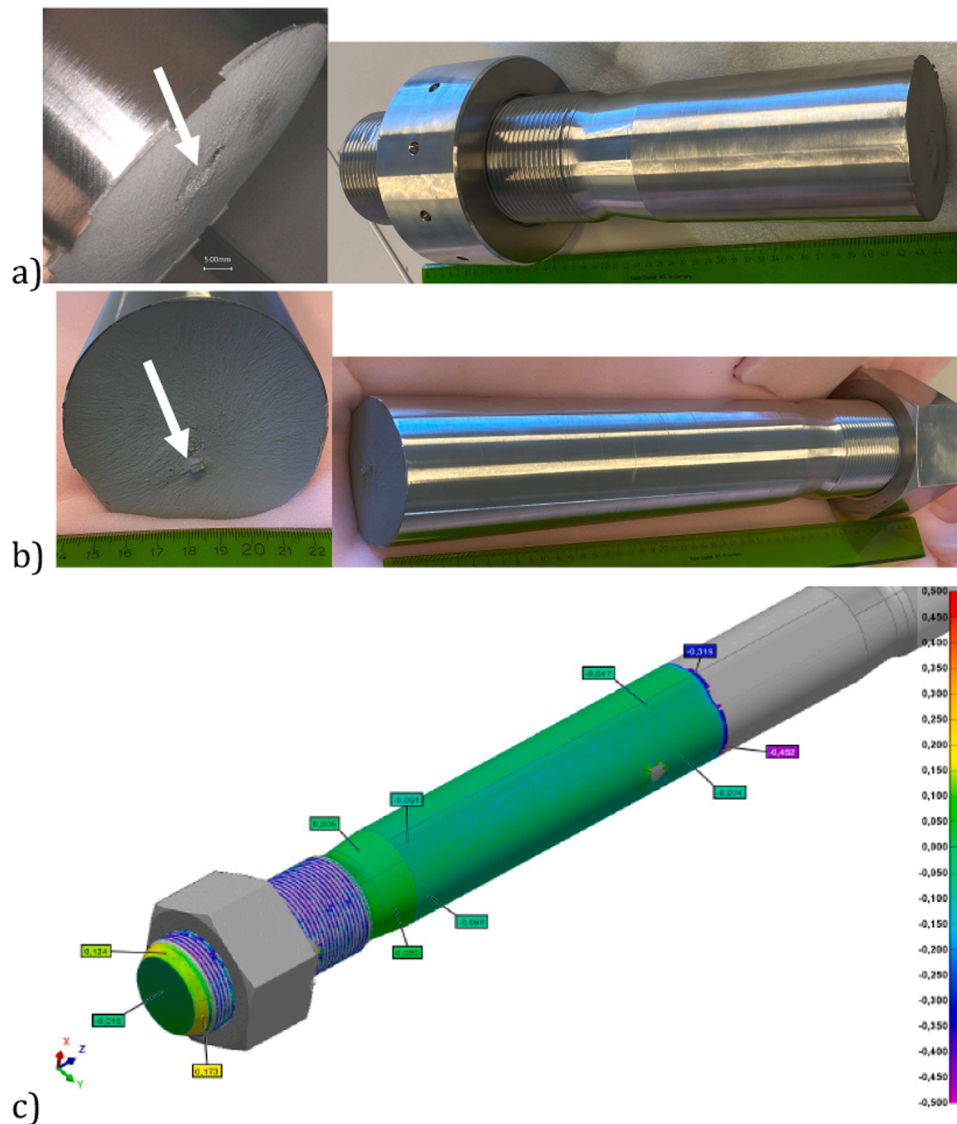
**Fig. 2.** Fracture surfaces of the broken stud (the initiation site is identified by a white arrow). a) top portion; b) bottom portion; c) dimensional metrology (top portion shown) concludes on almost total absence of necking.

Fig. 2 illustrates the appearance of the two fracture surfaces of the broken stud. The macroscopic observations confirm a very flat fracture and almost total absence of shear lips.

This is distinctive of limited ductility and is unexpected for this alloy, usually featuring cup-and-cone ductile fracture when broken by tensile overload [5]. Dimensional metrology (Fig. 2c) confirms absence of significant necking ( $< 1$  mm diametric reduction, corresponding to  $Z < 2\%$ , far below the minimum specified value of 15%). The initiation site is easily identified in the bulk, where all the river patterns converge. It spans over several tens of  $\text{mm}^2$ . It is slightly eccentric from the axis and far from the free surface, hence excluding a bending moment that would have occurred in operation due to misalignment or off-axis loading. Curved radial lines emanate from the eccentric initiation site and eventually propagate in a radial manner. SEM observations of the fracture surfaces (Fig. 3a) show a generalized quasicleavage, intergranular secondary cracks and interconnected networks of fractured precipitates. They reveal smooth surfaces and surface terraces, evidencing a pre-existing local lack of cohesion. Some surfaces at the initiation site show a solidification structure, pointing to cavities not closed by the forging reduction. Similar cavities were identified in the vicinity of the fracture surface by immersion UT and confirmed by CT and metallographic observations. In particular, some 10 mm upstream of the top fracture surface, a cavity was identified in the bulk at a radial distance of  $\sim 8$  mm from the axis, in a matching position with respect to the one of the initiation site (Fig. 4).

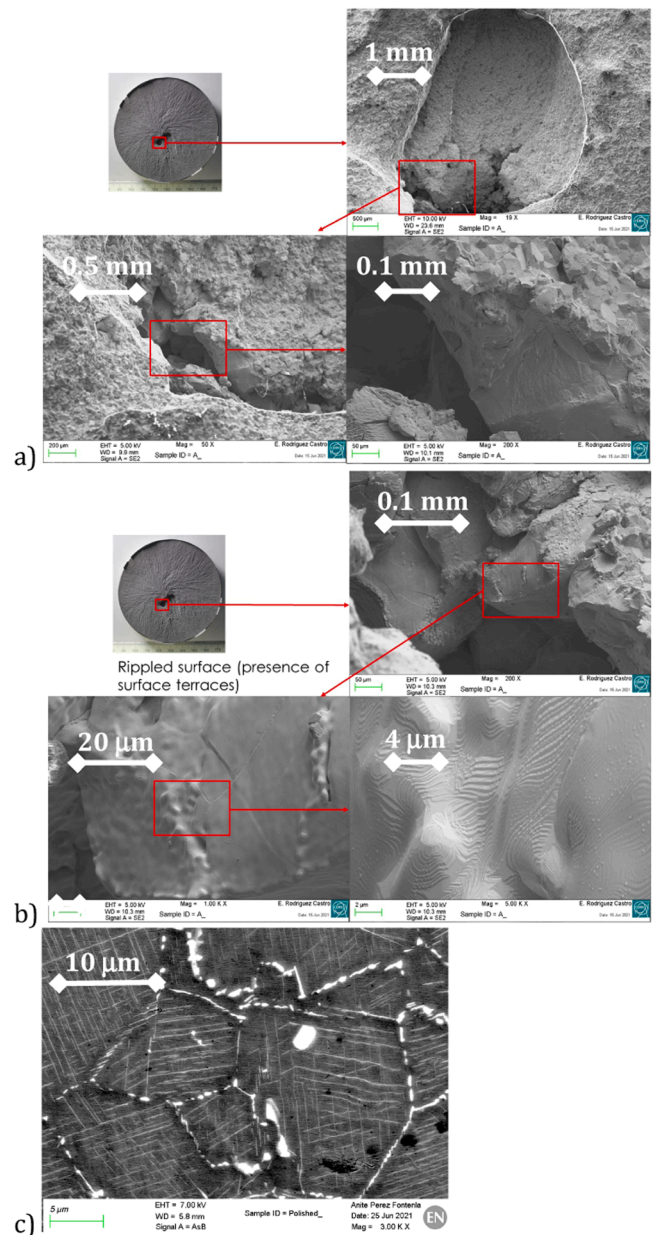
Grain structure is fine and equiaxed, with  $G$  spanning from 7 in the centre to 9 at the periphery of the stud, within the specified limits. However, GB decoration is widely observed (Fig. 3c), under the form of continuous networks of secondary phases along GB. The aspect of these precipitates is compatible with intermixed acicular  $\delta$ -phase and Laves' phase (platelets). EDS analyses and XRD confirm  $\delta$ -phase ( $\text{Ni}_3\text{Nb}$ ) and presence of Laves ( $\text{Fe}_2\text{Nb}$  crystal structure, enriched in Mo), whose composition assessed by EDS (30.6Ni14.3Fe13.1Cr12.2Mo14.3Nb) is compatible with the predicted one [6]. Isolated carbides ( $\text{NbC}$ ) are also observed. The excessive presence of  $\delta$ -phase at the GB is understood as due to the high Nb content of the alloy (over 5.3%), towards the high bound allowed by standards in force (5.50%), promoting GB precipitation when submitted to the standard ASTM A1014 heat treatment.

Fig. 3. SEM observations of the initiation site. a,b) A system of cavities in the continuity of the initiation event showing rippled surfaces is observed in the bulk of the stud; c) The Grain Boundaries (GB) are affected by an extensive precipitation of secondary phases.

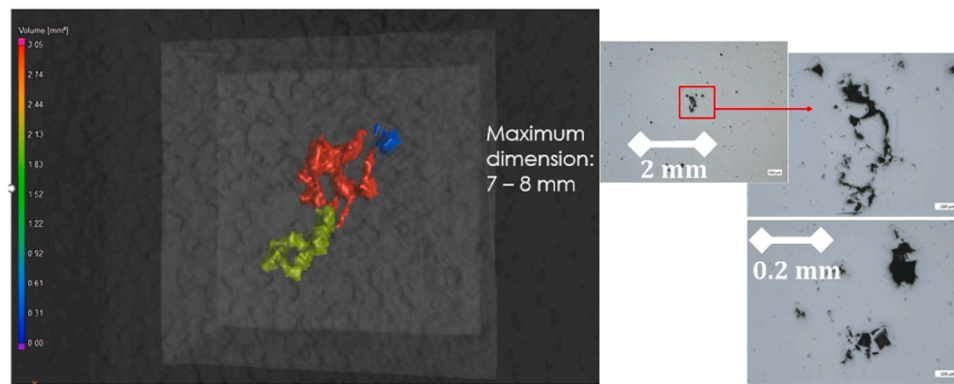
Fig. 4. Typical cavities as confirmed by CT (left) and microoptical observation (right) in the volume of material surrounding the breakdown.

The broken stud featured an extensive network of cavities at the fracture surface and in the adjacent volumes on top and bottom sides of the fracture, identified by UT and further confirmed by metallographic observations. These cavities were located mainly towards the inner diameter where also the initiation was identified. In the volume of the broken stud close to the rupture, results of tensile tests confirmed that the certified tensile properties were not fulfilled for any of the specimens. In particular, the specimens extracted from the inner position featured a very limited ductility. When observing the initiation site of their fragile tensile breakdown reproducing at a local scale the rupture of the stud featuring almost total absence of ductility, this coincides with a cavity or network of cavities. Based on the investigations performed, the delayed rupture of the stud is compatible with a failure under sustained tensile stress, initiating from a central position featuring very poor ductility, moreover severely weakened by the presence of a large network of cavities not closed by the forging operations. After an initiation time, the subsequent fast propagation through the extensive continuous network of intergranular  $\delta$  and Laves phases resulted in an overall brittle rupture with almost absent local necking. Even under a preloading stress lower than nominal, after a delay time the product was not forgiving due to the combined effect of an improper steel remelting, resulting in ingots affected by cavities that an insufficient forging reduction did not allow to close, and a non-optimised combination of composition and applied thermal treatment. This resulted in a

continuous network of secondary phases embrittling the GB and inducing a local lack of ductility, poor tensile strength and impact toughness. In order to exclude the simultaneous occurrence of cavities and embrittling phases, UT procedures were developed to confirm that the remaining bolts, including the installed ones, are free of cavities using sufficiently conservative criteria [4]. In particular, in-situ axial inspections allowed installed bolts that could contain relevant imperfections to be identified and replaced. Fatigue crack propagation behaviour is suggested to be considered for future work.
